Chapter 2: Hydrologic Needs – Effects of Hydrology on the Everglades

Fred H. Sklar, Christopher McVoy, Malak Darwish,
Steve Davis, Carl Fitz, Dale Gawlik, Shili Miao,
Mike Korvela, Chris Madden, Irv Mendelssohn, Sue
Newman, John Ogden, Jose Otero, Robert Shuford,
and Steve Smith

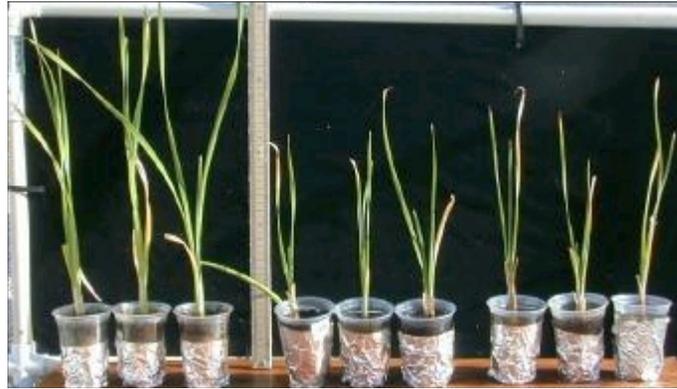
Figure 2-12. Cattail seedlings after 2 months of growth in muck-burned (left), surface-burned (middle), and non-burned (right) soils from the Rotenberger Wildlife Management Area.

Seedlings of the southern cattail (*Typha domingensis*) were used to assay Everglades soils that had recently experienced fire disturbance. After two months, growth patterns were sufficiently different to distinguish soils that came from areas that had been muck-burned (MB), surface-burned (SB), or non-burned (NB). Percent height gain, number of leaves, culm diameter, number of rhizomes, length of rhizomes, live leaf biomass and root biomass were all highest in the MB treatment. In addition, root architecture and biomass allocation was influenced by burn type. Seedlings from NB and SB treatments developed more root hairs and allocated more biomass to the root system - characteristics indicative of a search strategy under conditions of lower nutrient availability. In contrast, seedlings grown in muck-burned soils developed large rhizomes in addition to thicker, hairless roots but allocated a higher percentage of total biomass to leaves. Tissue nutrient

analyses showed that both assayed and field-harvested plants from MB soils assimilated more phosphorus than those from SB or NB soils. The results suggest that muck fire-related increases in the bioavailability of P may encourage cattail establishment and expansion in the Everglades (**Figure 2-12**). Chapter 7 provides a discussion of the role of fire in Everglades mercury levels.

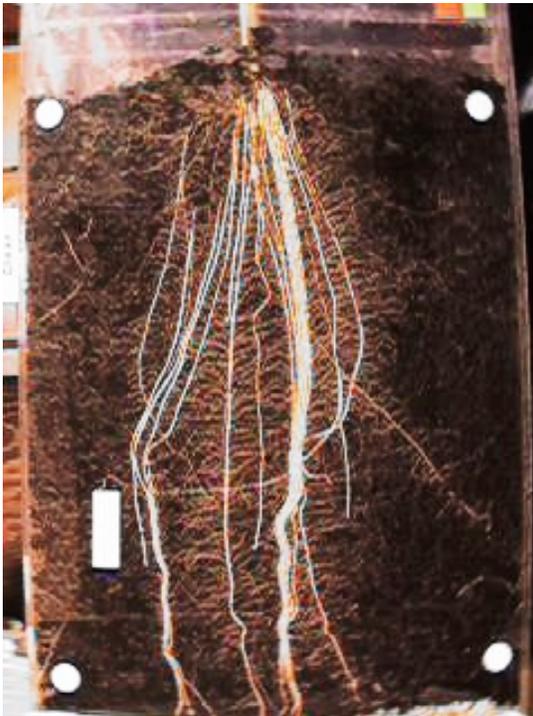
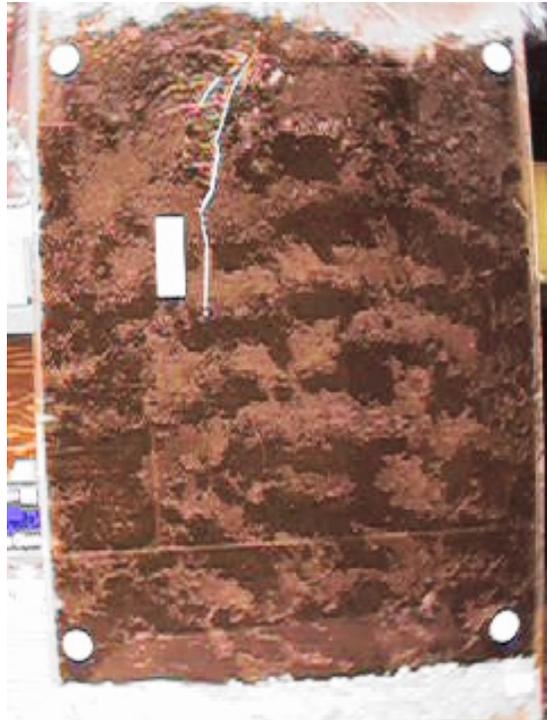
Figure 2-16. Root systems of *Typha* (A) and *Cladium* (B) grown in rhizotrons for 1 mo in flooded Everglades peat at high phosphorus loading. The white bar is 5 cm long.

- Under flooded conditions, the total number of primary roots produced by *Cattail* increased relative to the drained treatment (from 19 to 28 roots), but *sawgrass* root numbers did not change (4 roots) ($P = 0.0563$).
